Manhole Inspection Summary

Manhole # S13AA1007MH

Insp Date: **1/27/09 2:17 PM**

Location Address: **SPRINGHILL AVE**

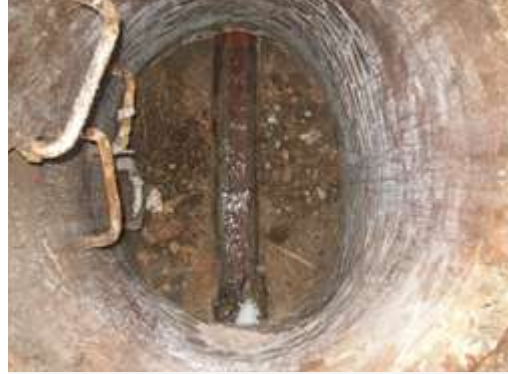
Top View

DEBRIS IN CHANNEL AND ON BENCH

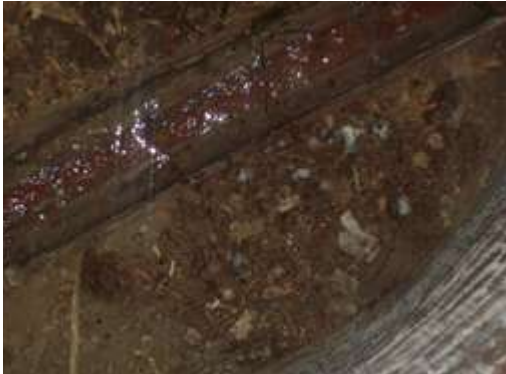
Defect 4

DEBRIS IN CHANNEL AND ON BENCH

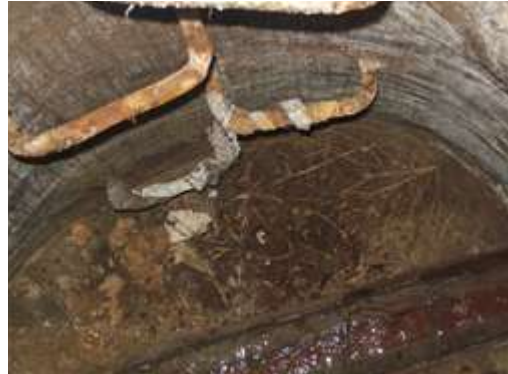
Defect 3

Surcharge ☒ **Evidence Of Surcharge** Depth: **4.** (ft.) ☐ Active Surcharge Present
35

EVIDENCE OF SURCHARGE

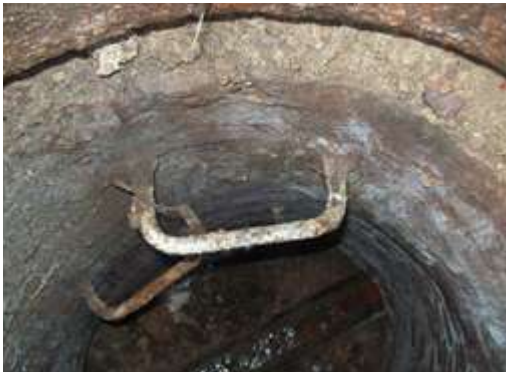
Defect 1

Condition: ☐ Sound ☐ Cracked ☐ Root Intrusion ☐ Loose Brick ☒ **Deteriorated**

Steps Count: **4** Missing: **0** ☒ **Corroded**

CORRODED STEPS AND
DETERIORATED CHIMNEY/FRAME
ADJUSTMENT

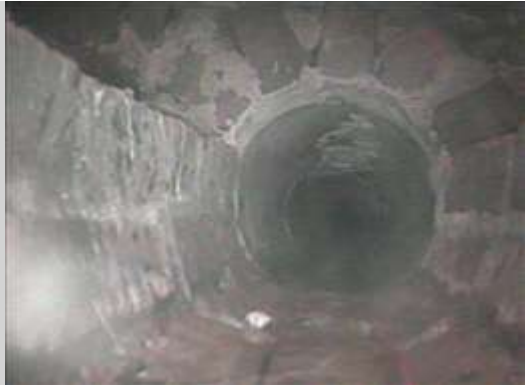
12 O'Clock Outflow

DEBRIS IN CHANNEL AND ON BENCH

Pipe Height: (in.) Direct
Pipe Material: **Clay** ☐ Pipe Lined
Invert Depth: **7.49** (ft.) Flow Characteristics: **Slow**
Deposits: ☒ None ☐ Mud ☐ Sludge ☐ Debris ☐ Grease
Silt Depth: (in.) Deposits Extent:
Infiltration: **None** Pipe Seal Cond: **Sound**

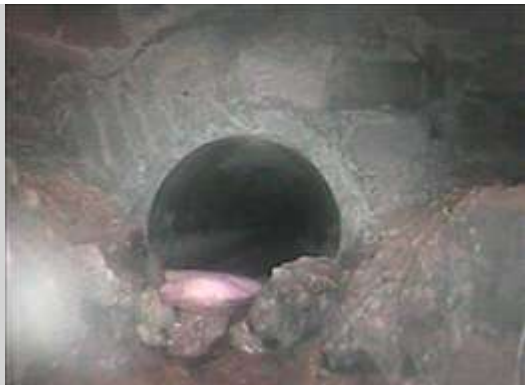
6 O'Clock Inflow

Pipe Height: (in.) Direct
Pipe Material: **Clay** ☐ Pipe Lined
Invert Depth: **7.44** (ft.) Flow Characteristics: **Slow**
Deposits: ☒ None ☐ Mud ☐ Sludge ☐ Debris ☐ Grease
Silt Depth: (in.) Deposits Extent:
Infiltration: **None** Pipe Seal Cond: **Sound**
